AVIATION INVESTIGATION REPORT

A03P0194

COLLISION WITH TERRAIN

LOCKHEED L-188 ELECTRA C-GFQA

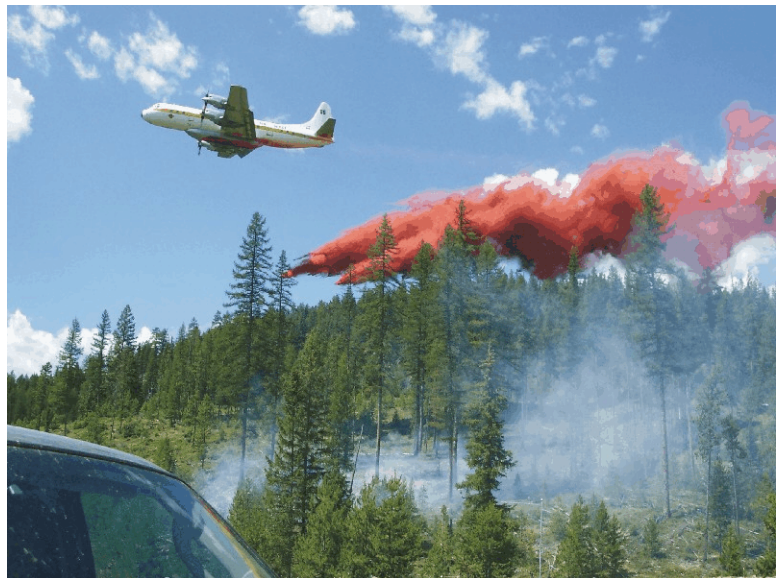
Photo 1. Tanker 86 delivers retardant to target fire at 1220 mountain standard time

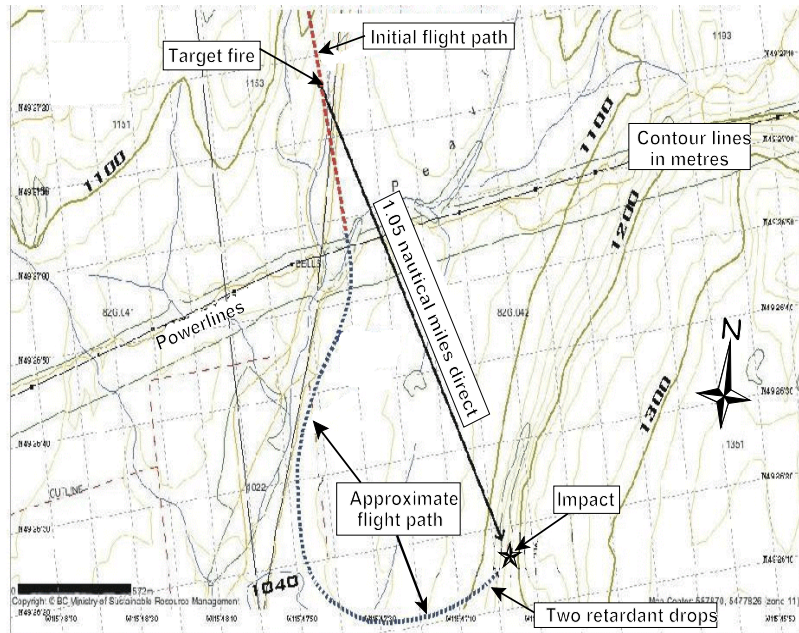
The bird dog joined up with Tanker 86 and followed on the left, rear quarter as it flew over the drop site. After the Electra released the specified retardant load, at 1220 mountain standard time (MST),² the bird dog entered a right-hand turn to circle the fire zone to allow the AAOs on the right side of the aircraft to assess the drop. At the same time, and as the Electra passed over the power lines, its flying pilot transmitted that they were in the right turn. The tanker was seen to turn right initially, then turn left. About 50 seconds later, Tanker 86 was seen in an extreme, left-bank angle immediately before it struck the ridge and exploded (see Figure 1).

Figure 1. Final flight path of Lockheed L-188 Electra C-GFQA

The distance from the power lines to the accident site is about 0.75 nm (4550 feet), and after the right-hand exit turn, the lateral span available across the valley to the ridgeline is about 0.65 nm (4000 feet). (See approximate flight path in Figure 1.)

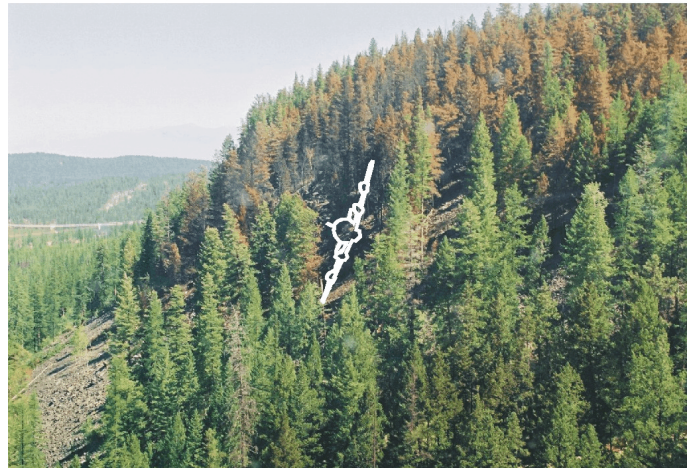
Tree damage and ground impact scars show that the Electra was in a left angle of bank of about 70° and nose-low when it first struck the trees at the edge of the accident site (see Photo 2). The terrain at the site is a steep and rugged talus, generally on a 45-degree slope from the ridgeline above, and thinly populated with tall evergreen trees. This part of the ridge juts out briefly from the smooth contour of the ridgeline and forms a "bulge."

Photo 2. Profile of C-GFQA at impact

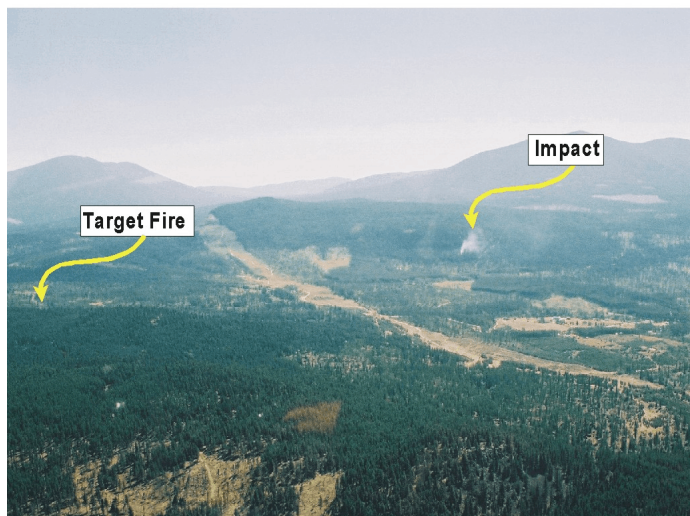
The surrounding area is more densely tree-covered and tends to conceal the bulge and rock outcrop that the aircraft struck. The terrain adjacent to the initial flight path slowly rises to the east and includes the accident site ridge, with the exit route down the valley toward the south and Moyie Lake (see Photo 3). This area provided ample manoeuvring room over relatively flat terrain. The ridge that the aircraft struck blended into the rising terrain and was not obviously separate from its surroundings.

Photo 3. View of valley to the southeast

Flight path recreation performed by both fixed- and rotary-wing aircraft at the same time of day and lighting conditions as the accident revealed that the ridgeline and the land mass that jutted out from it were particularly difficult to discern until about 0.5 nm away, even with prior knowledge. As well, the sun was overhead at the time of the accident and there was a lack of shadow relief, compounding the visual acuity problem.
